Landscape Inventory Report Drumlins Homeowner Association

Christopher J. Luley, Ph.D.
Vice President/Plant Pathologist
6050 Hicks Rd.
Naples, NY 14512
(585) 330-1722
chris@urbanforestryllc.com

August 2016

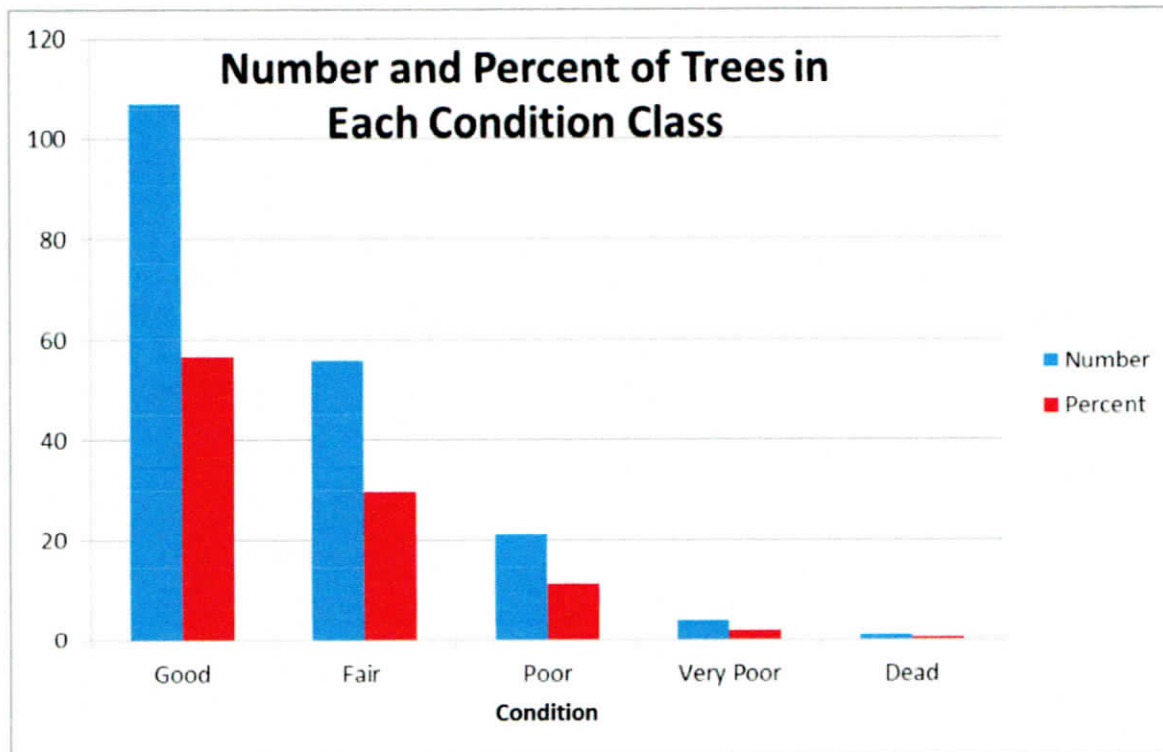
Figure 2. Number and percent of trees each condition class in the mowed landscape areas (note all numbers and percentages are approximate as trees in groups are represented as one tree).

Most trees were rated in good or fair condition (86%), and 13% were rated in poor or worse condition. There was only one dead tree on the property (Figure 2).
